Corrosion Under Insulation Inspection

SERVICE: REPAIR

PROJECT: Westminster Tower

CLIENT: Calibre Building Services Ltd

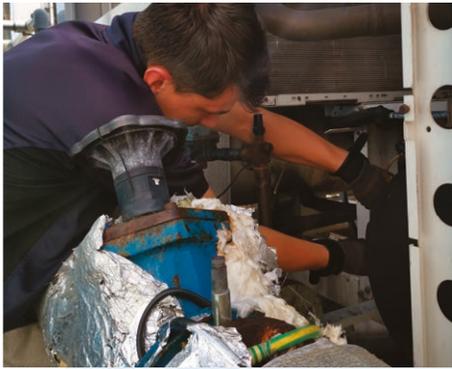
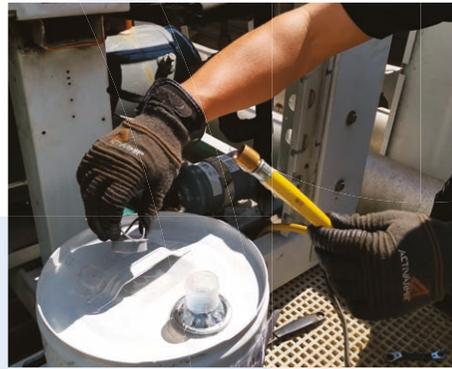
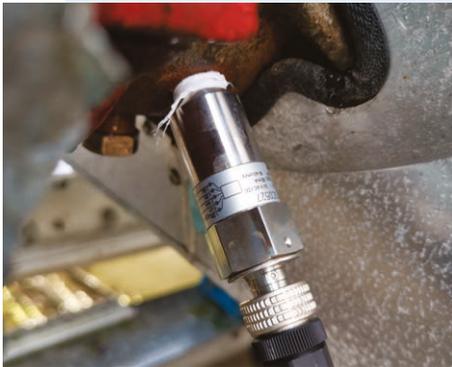
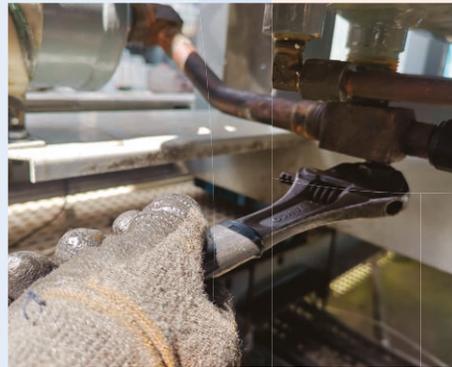
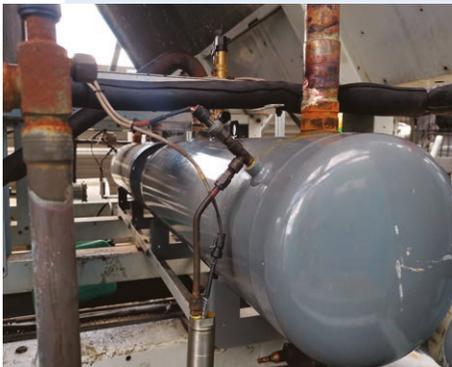
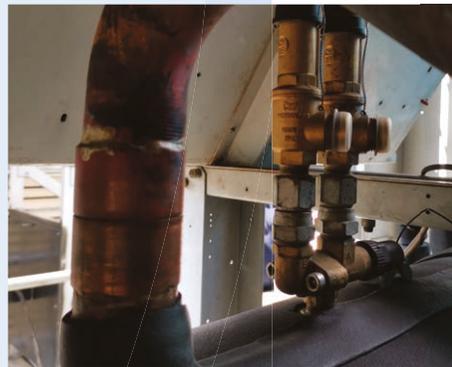
Once the lagging and oil heaters had been removed from the oil separators, it was clear to see significant corrosion with a large amount of pitting to the vessel mainly around the base of the shell; predominantly at the 6-8 o'clock position, where the oil heater pads were fitted as well as around the discharge pipe outlet connection. Further investigation of the area around the vessel data plate found it to be heavily corroded. The data plate was spot welded to the vessel on each corner and as such had allowed moisture to collect underneath. Accent were in no doubt that the circuit should not be reinstated back into operation without an (NDT) Non Destructive Test carried out by an independent accredited API 510 Inspector using ultrasonic thickness testing in accordance with ISO 17020 to the oil separators.

Seeing the results of the inspection and after consultation with Accent, Calibre elected to forego the NDT, deciding that the costs involved in further inspection coupled with the fact that there was a second chiller in the same condition, meant it made no financial sense to proceed with anything other than a complete replacement of all four oil separators across the two chillers.

Accent, promptly carried out this work and both chillers were again fully operational after four weeks on site from the date of the inspection.
