Corrosion Under Insulation Inspection

SERVICE: REPAIR

PROJECT: Westminster Tower

CLIENT: Calibre Building Services Ltd

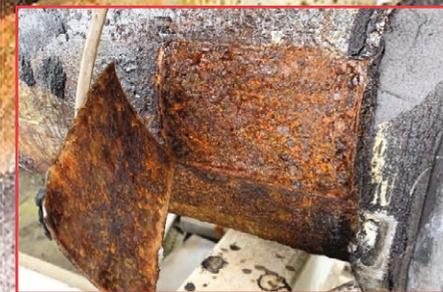
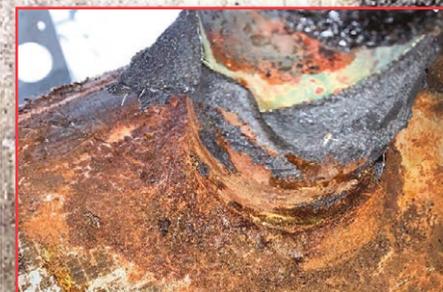
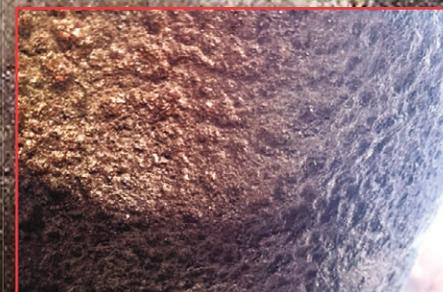
Once the lagging and oil heaters had been removed from the oil separators, it was clear to see significant corrosion with a large amount of pitting to the vessel mainly around the base of the shell; predominantly at the 6-8 o'clock position, where the oil heater pads were fitted as well as around the discharge pipe outlet connection. Further investigation of the area around the vessel data plate found it to be heavily corroded. The data plate was spot welded to the vessel on each corner and as such had allowed moisture to collect underneath. Accent were in no doubt that the circuit should not be reinstated back into operation without an (NDT) Non Destructive Test carried out by an independent accredited API 510 Inspector using ultrasonic thickness testing in accordance with ISO 17020 to the oil separators.

Seeing the results of the inspection and after consultation with Accent, Calibre elected to forego the NDT, deciding that the costs involved in further inspection coupled with the fact that there was a second chiller in the same condition, meant it made no financial sense to proceed with anything other than a complete replacement of all four oil separators across the two chillers.
